MR No. L4K14

ACCELERATIONS AND BOTTOM PRESSURES MEASURED ON A

B-24D AIRPLANE IN A DITCHING TEST

By Margaret F. Steiner

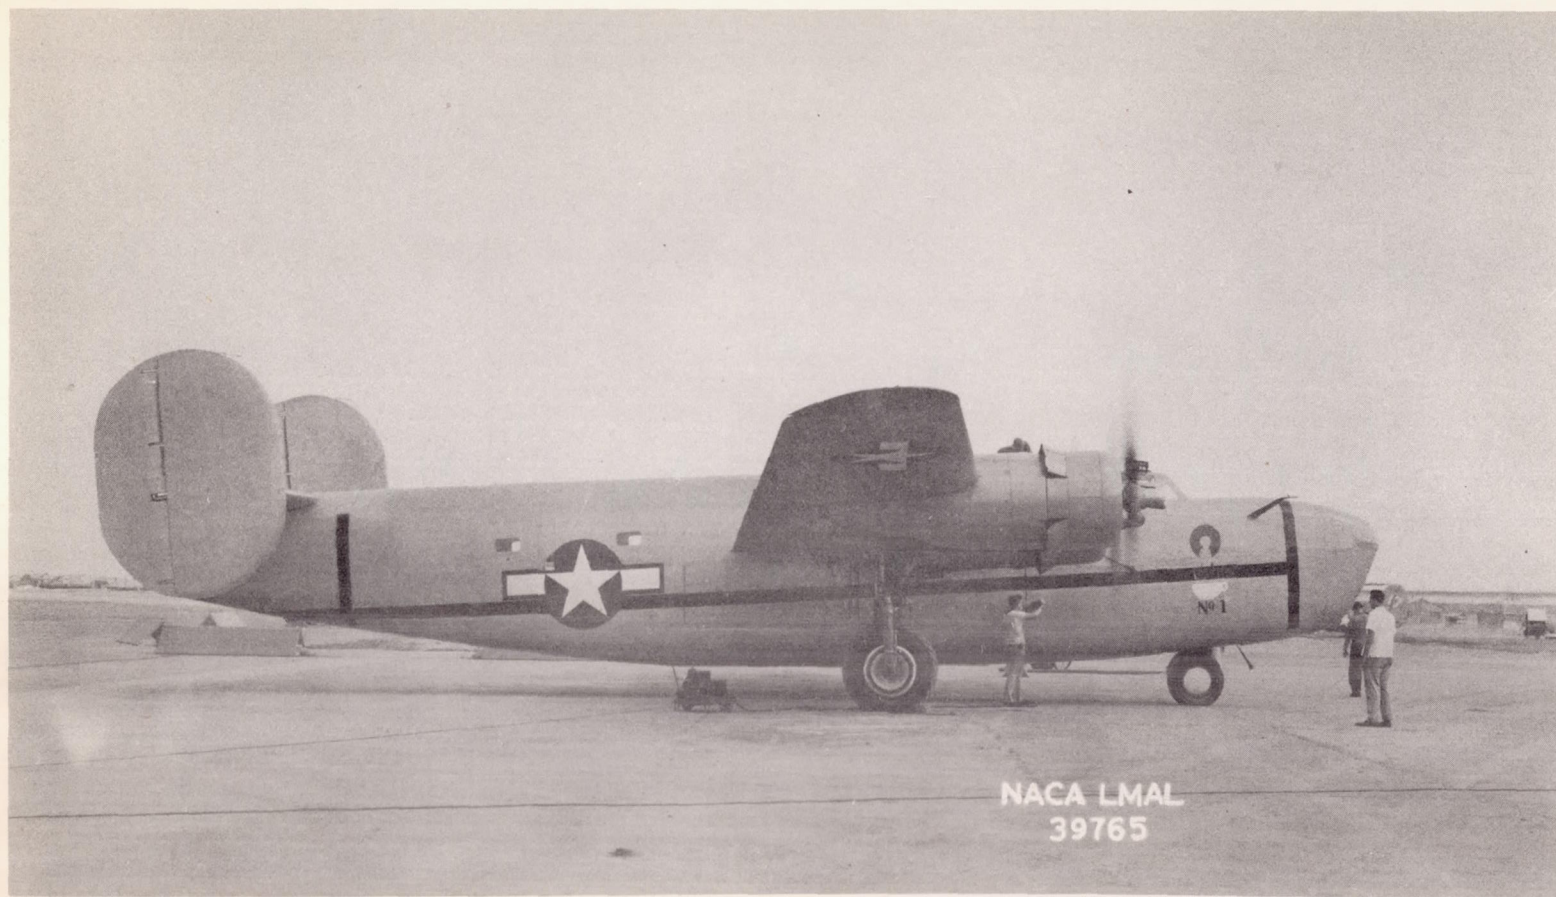
Figure 1 is a photograph of the B-24D airplane prepared for ditching. The weight of the airplane was about 44,100 pounds and the center of gravity was located at 30.9 percent of the mean aerodynamic chord.

The bomb doors and gun-turret well were replaced by  $\frac{1}{8}$ -inch steel plating; the camera hatch and plexi-glass sections of the nose were replaced by  $\frac{3}{32}$ -inch steel plating. Wooden bracings and steel reinforcing ribs were added throughout the fuselage structure.

Figure 1.- Photograph of an Army B-24D airplane prepared for a ditching.

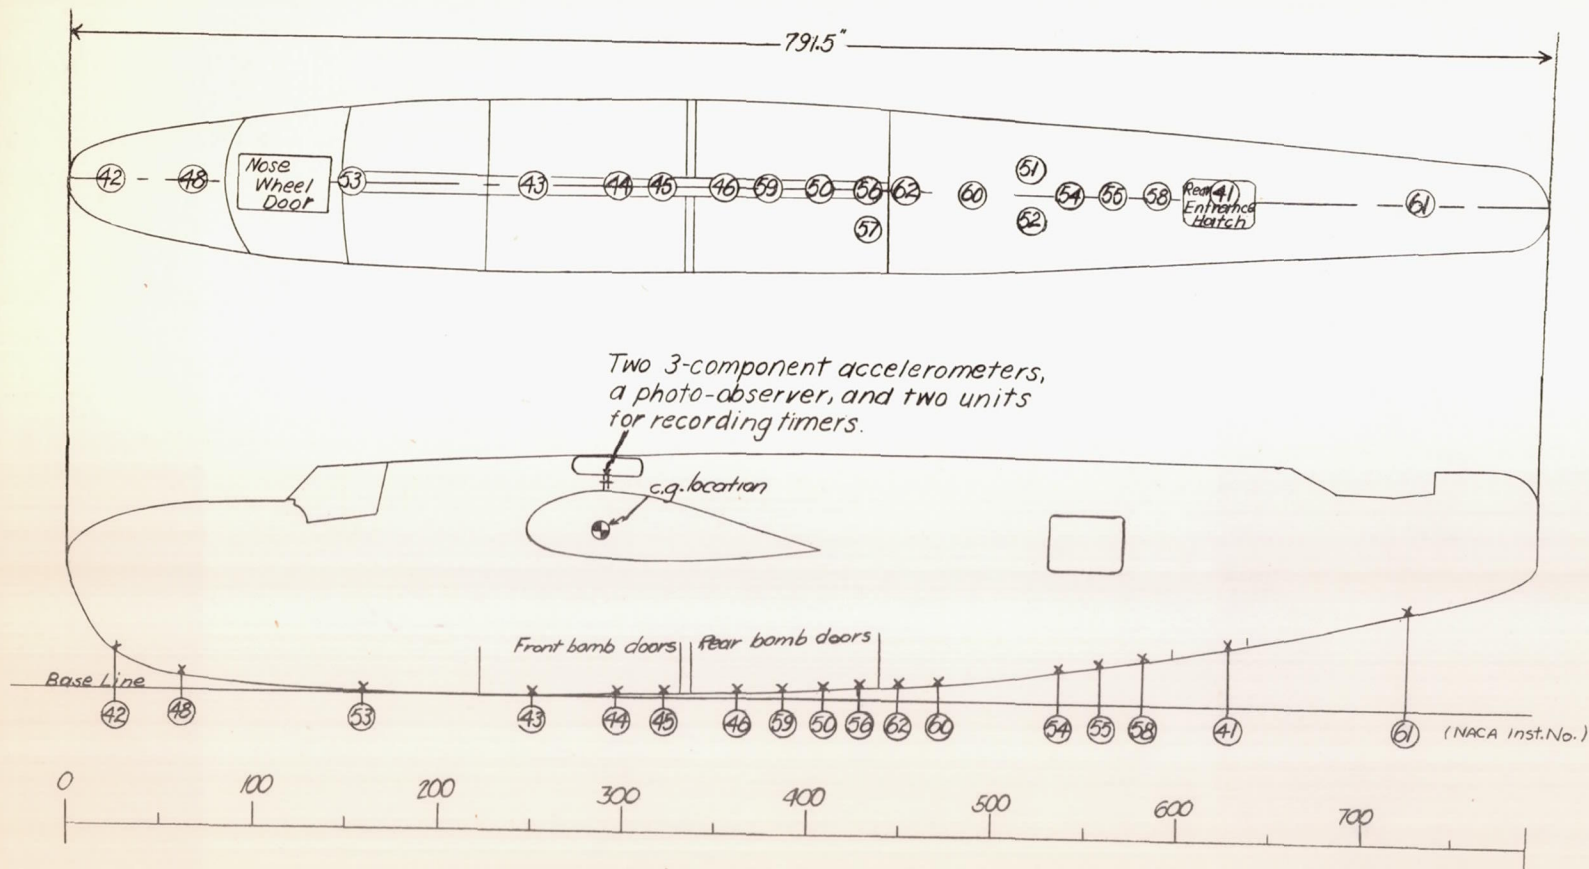
Twenty pressure recorders, all standard NACA instruments with corrugated diaphragms, were used in the test. The diaphragms had a diameter of  $1\frac{1}{8}$  inches and were mounted flush with the skin. Their location is shown in figure 2 and a typical installation is shown in figure 3.

Figure 2.- Location of the instruments on the B-24-D airplane with reference to existing structure.

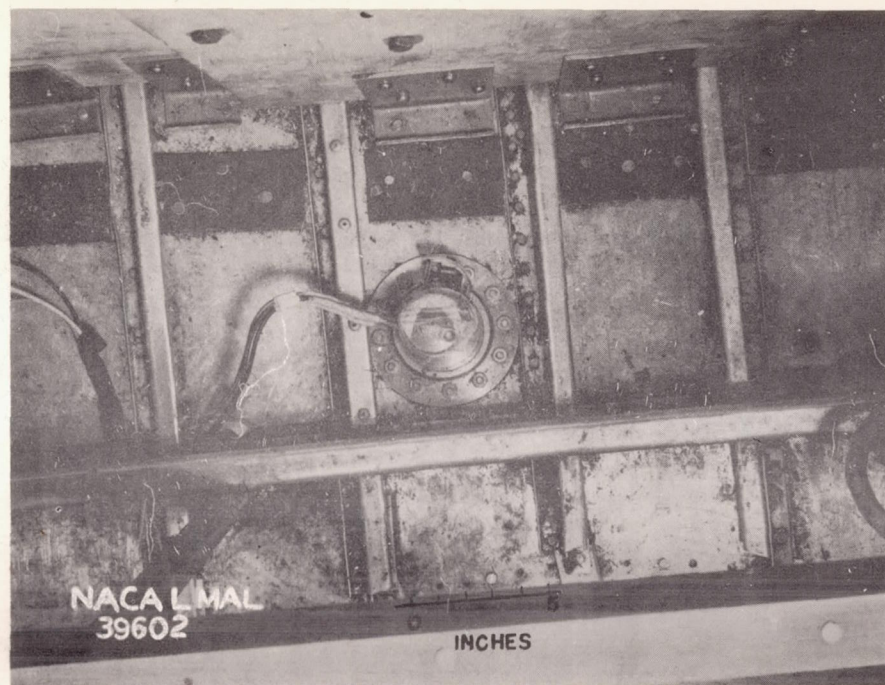
Figure 3.- Photograph of a typical installation of a time-history pressure recorder. Film magazine is partly removed from instrument.

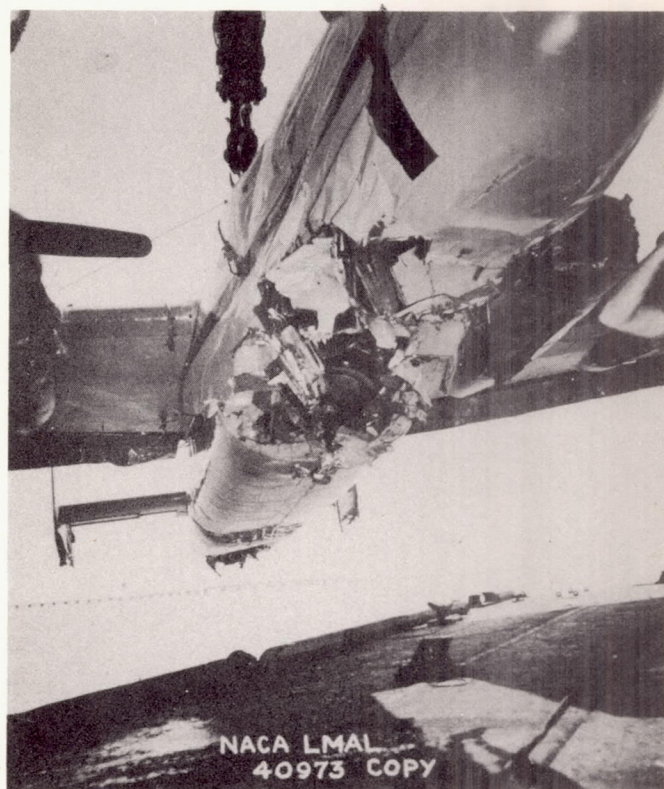
The pressure distribution holds for this reinforced airplane with its specific damage. The distribution would be different for a normal airplane in a ditching or for an airplane which remained undamaged. Figure 16 is a photograph of the B-24D fuselage bottom taken just after the airplane was retrieved from the James River. Note the damage in the nose-wheel area, the dent in the rear bomb doors, and the hole near bottom turret. Rudders were slightly damaged and the skin was indented over the lower half of the fuselage in a strip just in front of the empennage.

Immediately after first contact the area just aft the  $\frac{1}{8}$ -inch steel plating was forced inward, the skin was crushed at a section of the fuselage tail near the rudder hinge line, and the rudders were damaged.

the airplane rocked forward with the port wing low. These high pressures failed the bottom area just in front of the walkway. As the nose plowed through the water the steel reinforcement over the bombardier's sighting window was dented at which time the maximum decelerations also occurred. The damage around the nose-wheel door section apparently weakened the structure to such an extent that the nose section was almost broken away from the rest of the airplane.

Figure 16.- Photograph of B-24D fuselage bottom taken after airplane was removed from James River. Note damage in nose-wheel door area, dent in rear bomb door, hole near bottom turret, and damage to rudders. The skin was indented over lower half of fuselage in a strip just in front of the tail empennage.
